## Corrosion Testing of Graphene-Oxide-Polymer Coatings for Geothermal Drilling Applications

The Geo-Drill project aims to save time, increase service life of equipment and instrumentation, and reduce costs during drilling of geothermal wells by improving drilling methods with new materials and novel design of a down-the-hole (DTH) drill hammer. In the project polymer coatings (PTFE/PPS) with added graphene oxide (GO) nano-particles were corrosion tested at high temperature and pressure to evaluate the corrosion resistance in simulated geothermal drilling environment. The results from the corrosion testing of the PTFE/PPS-GO coatings in simulated geothermal drilling environment at two different conditions that can be encountered during drilling operation are reported here. One set of samples with various GO content was tested in moderately alkaline water, pH = 9, at 120 °C and 50 bar for 14 days; simulating normal drilling conditions. A second set of samples were tested at harsh conditions at 250 °C, 50 bar for a duration of 7 days in water (vapor and liquid phases) with CO<sub>2</sub> and H<sub>2</sub>S gasses added, which are conditions that can be encountered during geothermal

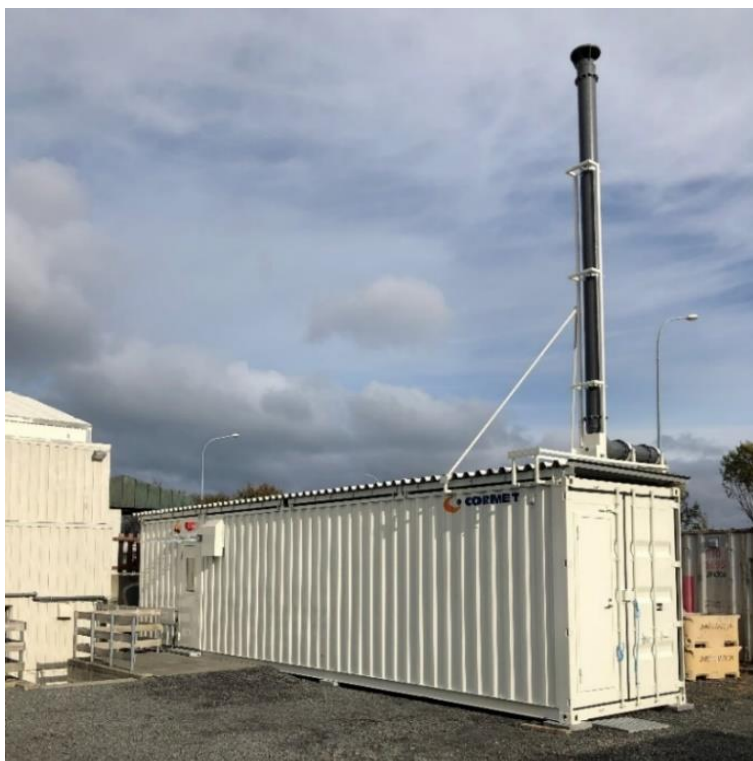
Figure 1 shows the recently installed laboratory capable of conducting high-pressure and high-temperature experiments with geothermal fluids at the University of Iceland. The laboratory was designed and constructed by Cormet Oy, Finland. It is equipped with gas detection and alarm systems to ensure safe operation for experiments with  $\text{H}_2\text{S}$  and  $\text{CO}_2$  gas. A 3 L autoclave made of C-276 Hastelloy\* and rated for pressures up to 300 bar and temperatures up to 500 °C is the key equipment in this laboratory (Figure 2). A custom-made stirrer impeller connected to a magnetic stirrer is installed in the autoclave lid. During an experiment, test samples are installed between the vertical supports of the custom-made sample holder, which is also attached to the lid. After installation of the samples and before starting an experiment, the lid, which is controlled by an electrical lifting mechanism, is lowered, and connected with 9 bolts to the autoclave vessel. Gauge pressure is measured with a Keller\* pressure transmitter and temperature is measured with a Pt100 temperature sensor in the vessel. Heating elements around the autoclave vessel control the temperature and insulation of the lid ensure low heat loss to the surroundings during experiments (Figure 3). The autoclave can be pressurized from the bottom gas inlet line with  $\text{N}_2$ ,  $\text{H}_2\text{S}$  and  $\text{CO}_2$ . Figure 3, right part of the photo, shows the gas filling panel with Brooks\* mass flow controllers that are used to fill a programmed quantity of each of the three gas components during the filling procedure. During depressurization, the gas is drained through gas draining line in the top and flows through three 20 L plastic containers (Figure 3, left part of the photo), filled with alkaline water solution containing dissolved zinc acetate and NaOH with pH =13.5. Zinc acetate reacts with  $\text{H}_2\text{S}$  gas from the autoclave and form solid  $\text{ZnS}$  that precipitates out of the solution and accumulates in the bottom of the plastic containers. There is also a valve for draining of liquid from the bottom of the autoclave.

**Figure 1: The corrosion laboratory constructed in a 40-foot high-cube container by Cormet Oy, Finland, shipped to Iceland, and installed at the campus of the University of Iceland.**

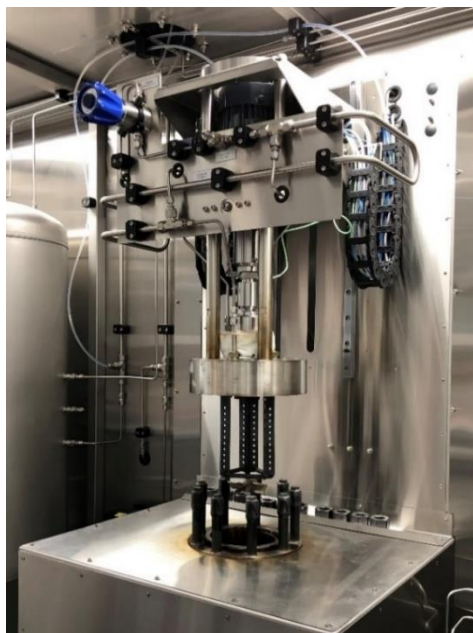
**Figure 2: The autoclave with the lid opened before installation of test samples.**

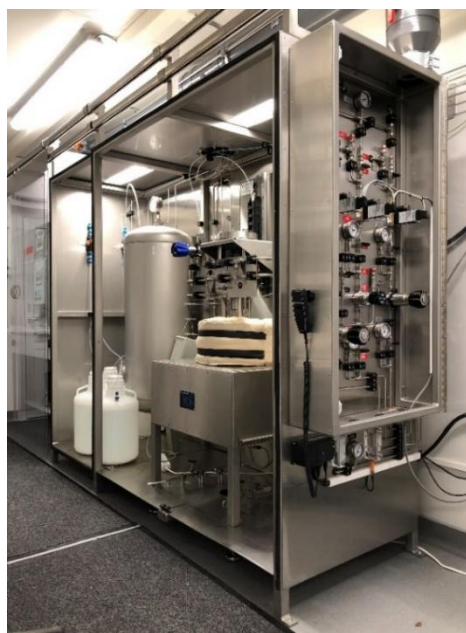
**Figure 3: Experimental setup with filling panel (right) and H<sub>2</sub>S capture system (left).**
