**“The Long-Term Effects of Surface Preparation: Evaluating ISO 12944-9 In Offshore Coating Application With Waterjetting And Decontamination Chemical”**

Jerry Woodson, P.E.  
Woodson Engineering  
621 Chadbourne Ct  
Houston, TX 77079  
USA

Alex Petkas, PhD  
HoldTight Solutions, Inc.  
3100 Timmons Ln, #260  
Houston, TX 77027  
USA

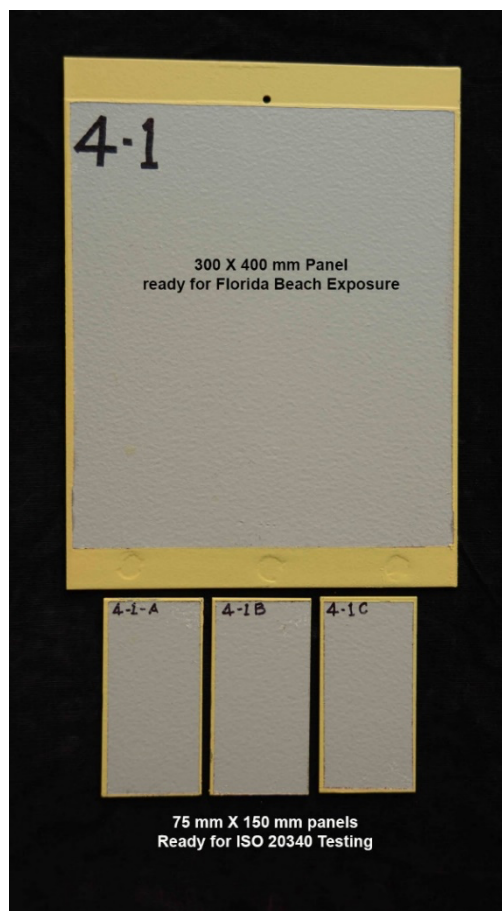
**Figure 2: prepared panel**

After coating, the original 300 mm X 600 mm (12" X 24") panels were cut into four pieces. One large 300 mm X 400 mm (12" X 16") piece from each was sent to the NASA BCTS facility described above for atmospheric testing. Three each smaller 75mm X 150mm (3"x6") panels were submitted for laboratory testing per ISO 20340<sup>1</sup>.

This method of preparation and then cutting and dividing was employed so that the panels subjected to ISO 20340<sup>1</sup> and the long-term atmospheric testing would be prepared in as uniform a manner as possible, allowing for more rigorous analysis and comparison of the results of both test methods.

Before being sent to their respective testing facilities, the panels were edge coated with a **yellow** epoxy, to seal the edges and protect them for transit. This contrasted with the **white** epoxy of the surface subjected to rigorous testing.
