## Ingress/Egress Safety Belt Pyrotechnic Lap Pretensioner (PLP) Durability Test

**1.1 Purpose.** This test is used to evaluate wear and durability of a completely trimmed seat cushion and back assembly with safety belt Pyrotechnic Lap Pretensioner (PLP), when subjected to occupant, ingress, seating and exiting the vehicle on the seat.

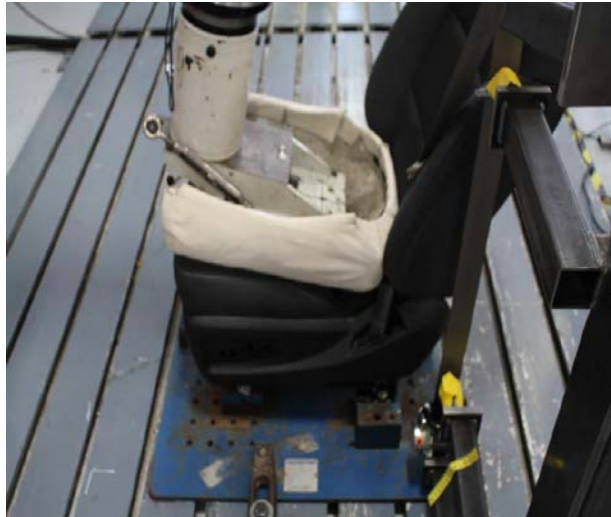
**Figure 1: Robotic and Form Apparatus**

**3.2.3** Robotics capable of motion planning of 10 Hz or higher. Additionally, the software must be capable of compensating for load for every point of motion, and load controlled sinusoidal motion of 2 Hz. (See Figure 1).
