## Natural Weathering Exposure Tests for Interior Trims/Materials

**1.1 Purpose.** This test procedure describes procedures for conducting natural weathering exposure tests to evaluate the exposure tolerance of interior automotive materials, components and assemblies. The tests are conducted in climatic regions which offer extreme solar environments.

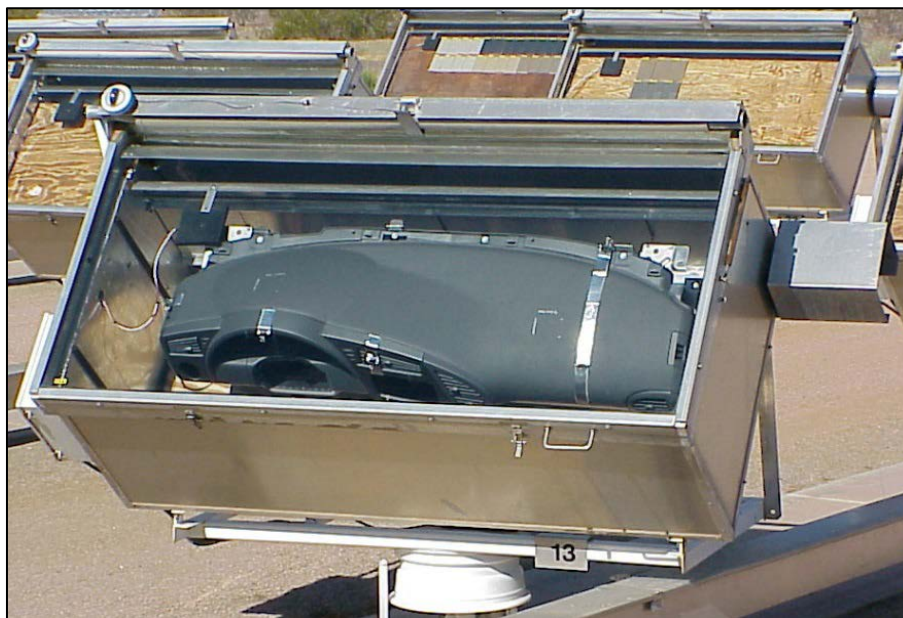
Figure 1: Code F2 Test Fixture with Instrument Panel Trim Assembly

- Code F1 = High temperature limited, enclosed with operable vents, under glass, static box.
- Code F2 = High temperature limited, enclosed with operable vents, under glass, tracking box. See Figure 1, Figure 2, Figure 3, and Figure 4.
- Code F3 = High temperature limited, enclosed with operable vents, under glass, dual-axis tracking box, with upper and lower mirrors. See Figure 5.

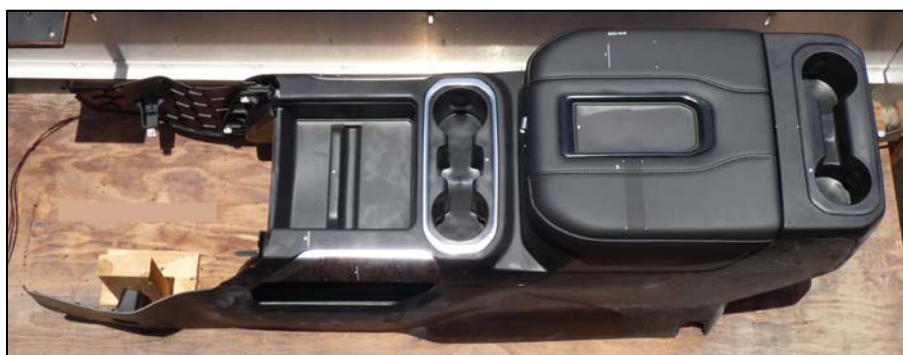
Figure 2: Code F2 Test Fixture with Floor Console Assembly

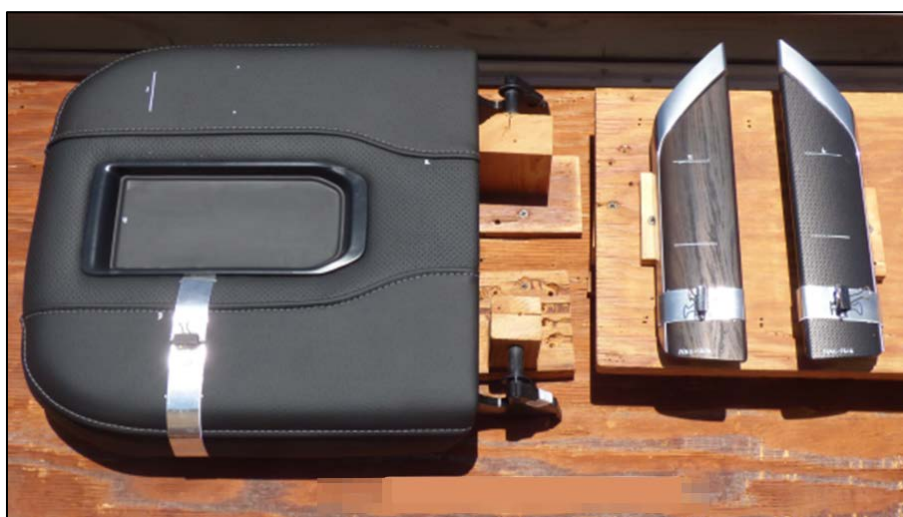
Figure 3: Code F2 Test Fixture with Floor Console Components

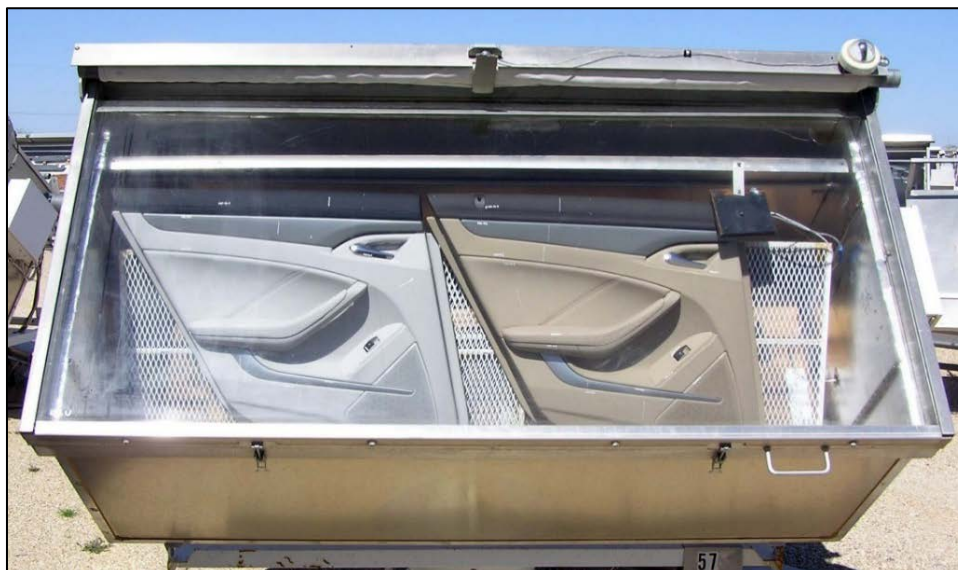
Figure 4: Code F2 Test Fixture with Door Trim

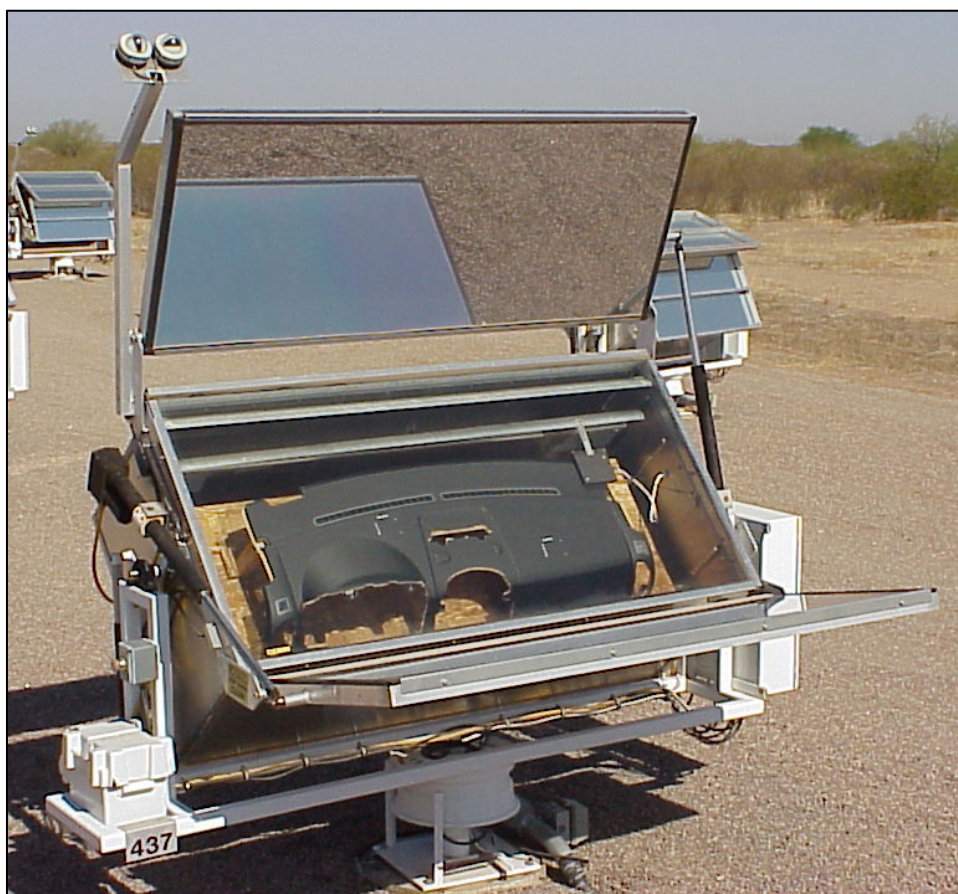
Figure 5: Code F3 Test Fixture with Instrument Panel Upper Trim
