# Patrol Route Plan

## Central Line Route CN21A: Hanger Lane to North Acton EB

R2742, Issue: A1, January 2014

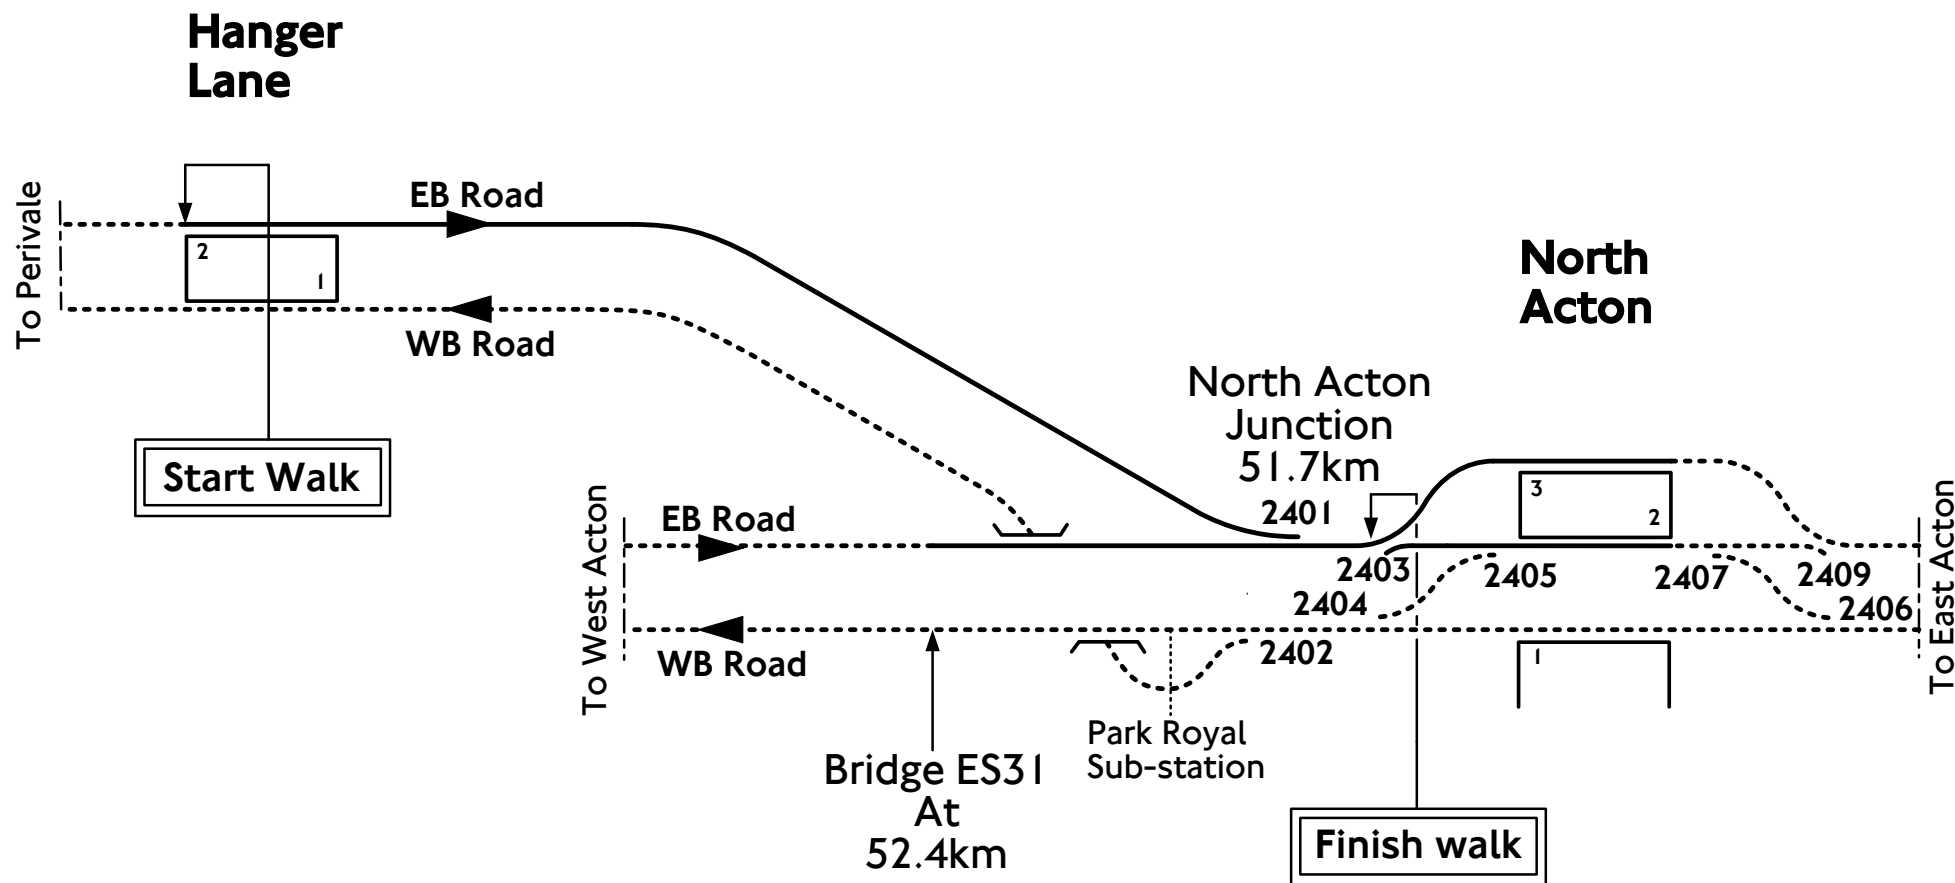
**CN21A Patrol**

Patrol starts at the west end of Hanger Lane platform 2.  
LCS C153/CEBFA 0m

Obtain briefing from supervisor and travel to Hanger Lane Station.  
 Once traction current has been discharged and protection arrangements are in place, patrol the eastbound road eastwards to the toes of 2401 points.  
 Inspect all P&C associated with 2401 points.  
 Patrol the eastbound (Ealing Broadway) road westwards towards bridge ES31 at 52.4km.  
 End this part of the patrol at bridge ES31 and dead walk back to the toes of 2401 points.  
 Patrol eastwards on the eastbound road to the east end of North Acton platform 3, via 2403 points.  
 Inspect all P&C associated with 2403 points.  
 Cross over to the east end of North Acton platform 2 and patrol the middle road westwards to the toes of 2403 points to finish the patrol.  
 Inspect all P&C associated with 2405 points.  
 Complete the patrol reporting process as in W1328 Patrolling the track.
