# NOTICE BOARD

NB 143  
Issue 1  
14/08/2015  
Expires: 31/08/2016  
Page 1 of 2

NETWORK RAIL - SIGNAL ENGINEERING

## Level Crossing Road Traffic Lights – synchronisation of flashing red aspects

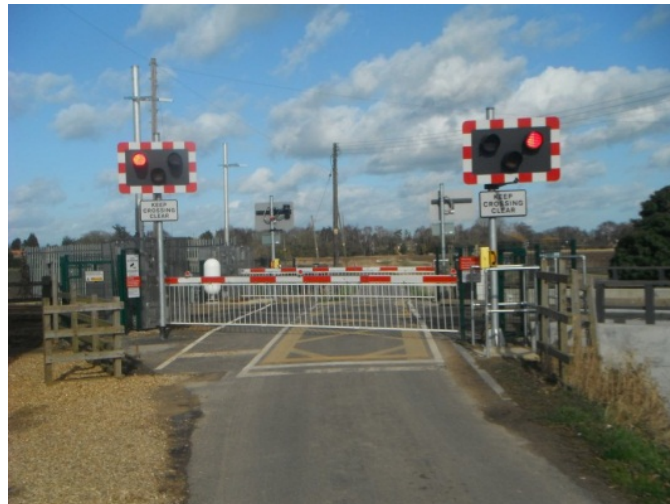
**Figure 1**

Figure 1 shows pairs of Wig-Wag signals not flashing in synchronisation i.e. Left Hand light and Left Hand light.

The phenomenon may be explained by differences between Westrace controlled and traditional relay circuit controlled road traffic lights. The former are driven by separate electronic flasher circuits, whereas the latter are driven from a single flasher relay.

No action is required to change the infrastructure.
