| Ref: | NR/L2/ELP/27009/MOD C05 |

| OVERHEAD LINE CAMPAIGN CHANGES – DATA SHEET | |
| <b>05</b> | <b>REPLACEMENT OF ILLEGIBLE STRUCTURE NUMBER PLATES<br/>(STENCILLED TYPES)</b> |

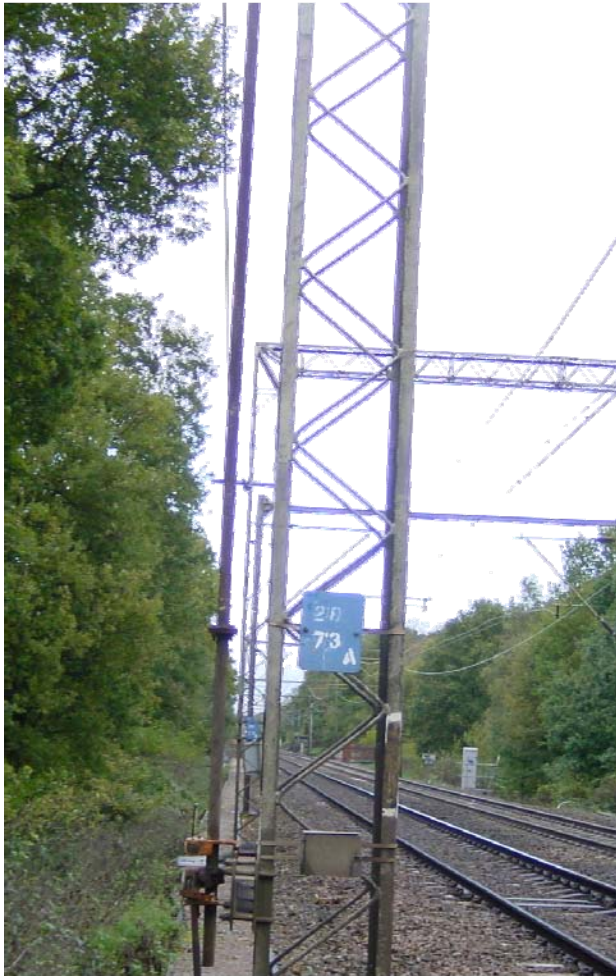
| OVERHEAD LINE CAMPAIGN CHANGES – DATA SHEET | |
|---|---|
| <b>COMPONENT</b> | Various stencilled types of structure number plate. |
| <b>PROBLEM</b> | Illegible structure number plates lead to lost time due to inaccurate location reports of incidents or defects; this is also a safety issue due to incorrect identification of switching or earth locations. |

| OVERHEAD LINE CAMPAIGN CHANGES – DATA SHEET | |
|---|---|
| <b>ACTION<br/>REQUIRED</b> | <p>1. Replace the illegible structure number plates with die pressed aluminium plates to drawing 1/148/812.</p> |
