| Ref: | NR/L2/ELP/27009/MOD C08 |

| OVERHEAD LINE CAMPAIGN CHANGES – DATA SHEET | |
| <b>08</b> | <b>REPLACEMENT OF SOLID CORE PORCELAIN INSULATORS IN TERMINATIONS VULNERABLE TO VANDALISM CATASTROPHIC FAILURE</b> |

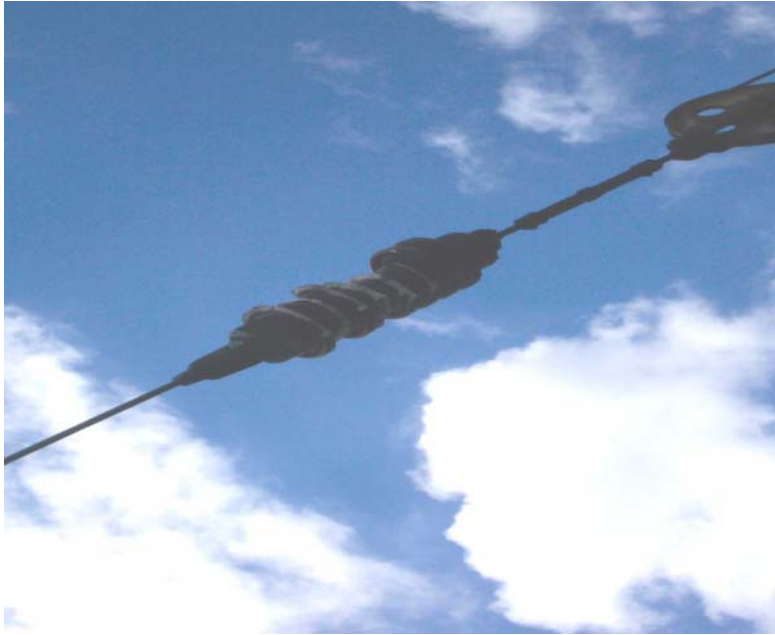
| OVERHEAD LINE CAMPAIGN CHANGES – DATA SHEET | |
|---|---|
| <b>COMPONENT</b> | Solid core porcelain insulators in termination arrangements. |
| <b>PROBLEM</b> | Any damage to the porcelain core of the insulator results in catastrophic failure and dewirement.<br><br> |

| OVERHEAD LINE CAMPAIGN CHANGES – DATA SHEET | |
|---|---|
| <b>ACTION REQUIRED</b> | Replace solid core porcelain insulators in terminations with the appropriate equivalent polymeric insulator. |

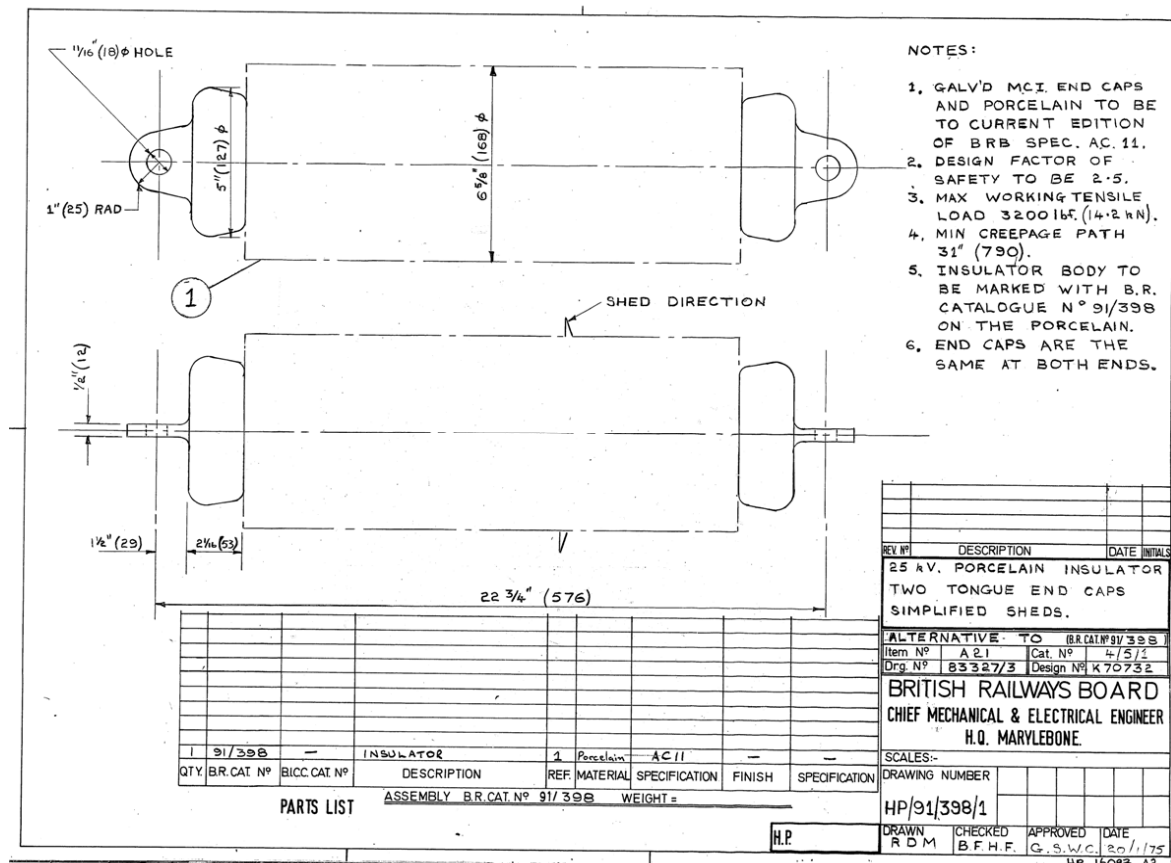
Part number 91/398 – equivalent to Item A21 (Mark 1 solid core tension insulator)
