| Ref: | NR/L2/ELP/27009/MOD C10 |

| OVERHEAD LINE CAMPAIGN CHANGES – DATA SHEET | |
| <b>10</b> | <b>DAMAGE TO STRANDED CATENARY FROM BIRD INITIATED SHORT CIRCUITS AT PORTAL STRUCTURES</b> |

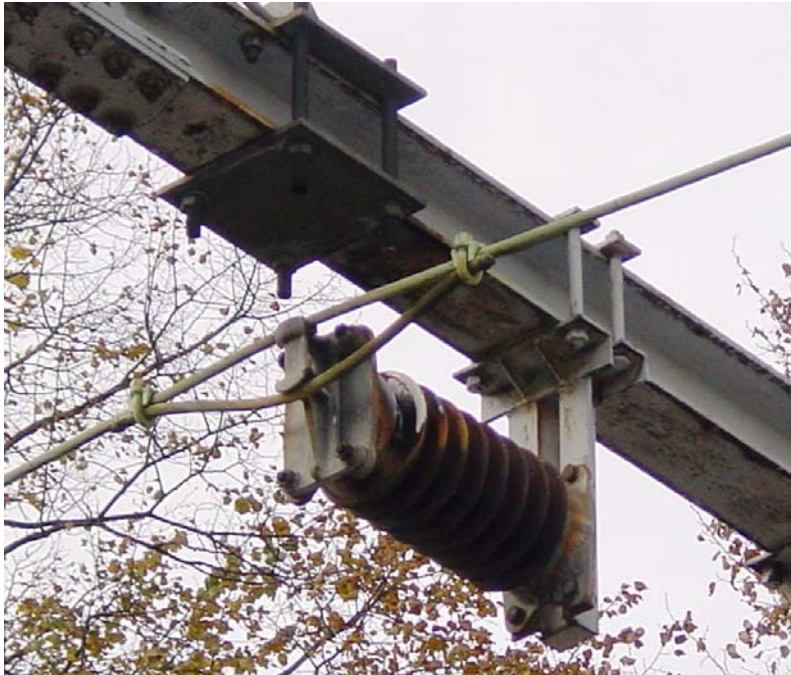
| OVERHEAD LINE CAMPAIGN CHANGES – DATA SHEET | |
|---|---|
| <b>COMPONENT</b> | Catenary wire and supports at portal structures |
| <b>PROBLEM</b> | <p>Bird strikes at portal structures cause short circuits from live equipment to earth and circuit breaker trippings. Where stranded catenary runs through the bridge, these short circuits cause conductor stranding with a risk of dewirement.</p> <p>This campaign change is related to campaign changes 31, 32 and 33 and also to campaign change 20 (see actions required).</p> |

1. Increase electrical clearance to 600mm minimum;
2. Install inverted cantilever catenary support (for catenary support above the boom, to increase electrical clearance);
3. Fit anti bird secondary insulation mats to the structure;
4. Cut in solid conductors at support. This solution will reduce the risk of conductor stranding but will not reduce the risk of circuit breaker trippings.

This campaign change can be delivered together with campaign change 20 when fitting inverted cantilever catenary supports.

Do not use secondary insulation as a justification for infringing minimum electrical clearances.
