| Ref: | NR/L2/ELP/27009/MOD C22 |

| OVERHEAD LINE CAMPAIGN CHANGES – DATA SHEET | |
| <b>22</b> | <b>FOULING OF DEEP CURVED STEADY ARM ANTI-WIND STIRRUPS / PROTECTIVE SADDLES</b> |

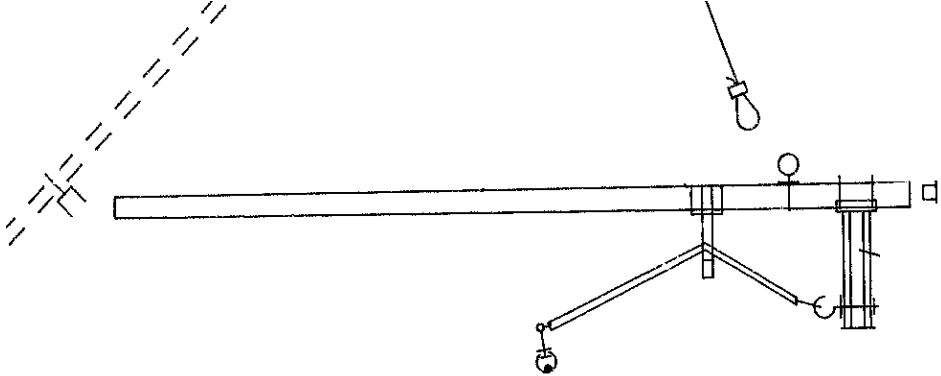
| OVERHEAD LINE CAMPAIGN CHANGES – DATA SHEET | |
|---|---|
| <b>PROBLEM</b> | <p>These stirrups were fitted as an alternative design to windstay droppers in high speed registrations subject to large uplift. However the protective saddle moves along the registration tube and fouls the stirrup, causing the steady arm to stick in the uplifted position.</p> <p>Stirrup and protective saddle. 123/086/001-004 143/155/001</p> |

| OVERHEAD LINE CAMPAIGN CHANGES – DATA SHEET | |
|---|---|
| <b>ACTION REQUIRED</b> | <p>1. Remove the anti-wind stirrup assembly and and fit a registration tube link assembly. See drawing 199/472.</p> <p>Remove stirrup and fit brace link. 123/086/001-004 143/155/001</p> |
