| Ref: | NR/L2/ELP/27009/MOD C37 |

| OVERHEAD LINE CAMPAIGN CHANGES – DATA SHEET | |
| <b>37</b> | <b>REPLACEMENT OF BICC HIGH SPEED SECTION INSULATOR WITH ARMOUR PLATE GLASS INSULATION</b> |

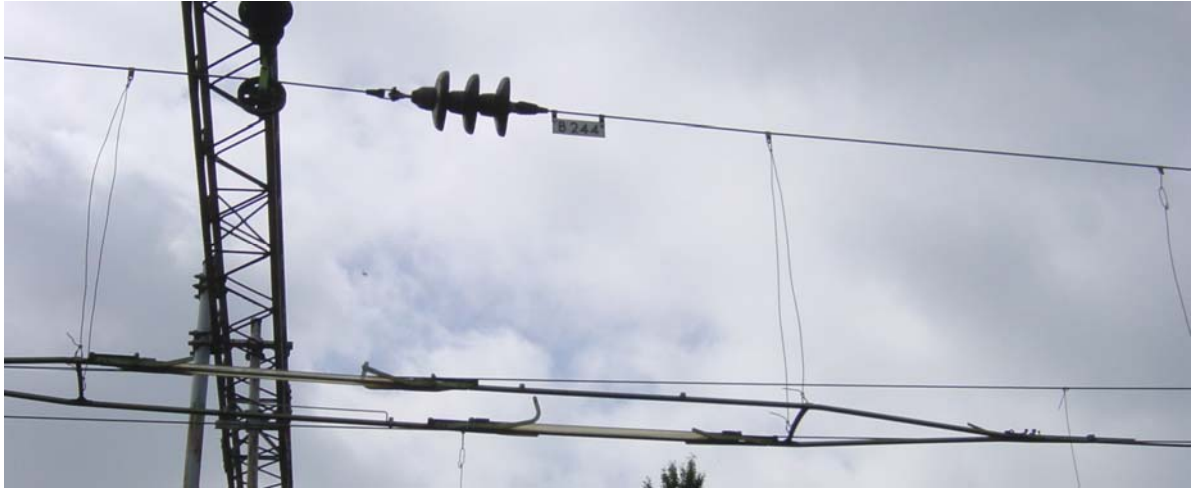
| OVERHEAD LINE CAMPAIGN CHANGES – DATA SHEET | |
|---|---|
| <b>COMPONENT</b> | BICC high speed section insulators with armour plate glass insulation runners. |
| <b>PROBLEM</b> | The glass runners are vulnerable to vandalism and other shock loads. Once the runners are broken, the section insulator causes damage to pantograph carbons. |

| OVERHEAD LINE CAMPAIGN CHANGES – DATA SHEET | |
|---|---|
| <b>ACTION REQUIRED</b> | <ol style="list-style-type: none"> <li>1. Replace the section insulator with a current approved design.</li> <li>2. Alternatively, replace the armour plate glass runners with ceramic bead insulators.</li> </ol> |
