| Ref: | NR/L2/ELP/27009/MOD C47 |

| OVERHEAD LINE CAMPAIGN CHANGES – DATA SHEET | |
| <b>47</b> | <b>REMOVAL OF CONTACT WIRE SPLICES INSTALLED NEXT TO REGISTRATION ARMS OR IN 1ST DROPPER PANELS</b> |

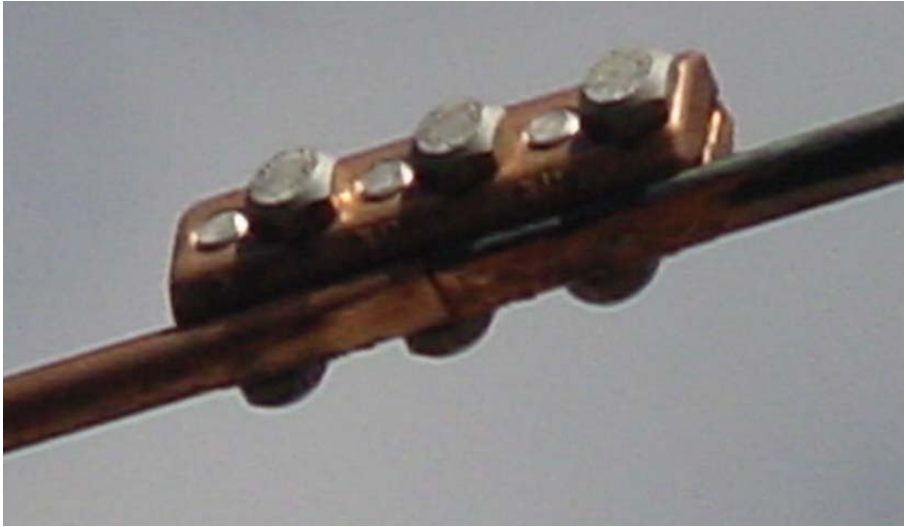
| OVERHEAD LINE CAMPAIGN CHANGES – DATA SHEET | |
|---|---|
| <b>COMPONENT</b> | Contact wire splices, where installed next to registration arms or in the first dropper panel. |
| <b>PROBLEM</b> | The increase in span mass of the splice leads to higher pantograph contact forces, poor current collection and rapid wear of contact wire and pantograph carbons. |

| OVERHEAD LINE CAMPAIGN CHANGES – DATA SHEET | |
|---|---|
| <b>ACTION REQUIRED</b> | Cut in new lengths of contact wire and relocate splices to optimum locations within span. |
