| <b>TECHNICAL INSTRUCTION</b> | | <b>TI 165</b><br><b>Issue 1</b><br><b>18/10/2011</b><br><b>Page 1 of 3</b> |
| | <b>NETWORK RAIL - SIGNAL ENGINEERING</b><br><b>M30 Hard-Lock Nuts for Adjustable Stretcher Bar Assemblies</b> | |

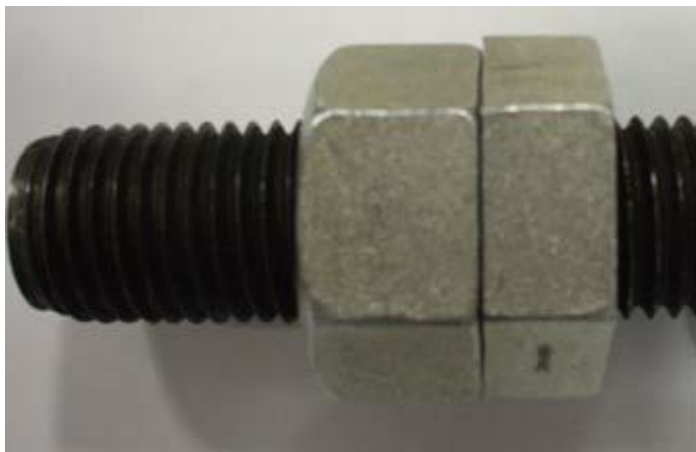
A team recently undertaking the task of replacing conventional lock nuts on adjustable stretcher bars noted that when fitting replacement M30 Hard-Lock nuts the male and female nuts closed together when tightened by hand. The locking function of Hard-Lock nuts requires a gap between the male and female nuts to be present prior to tightening to the installation torque value.

Subsequent checks found that on some bars the diameter of the threaded portion of the bar is at the bottom of the acceptable diameter range (29.6 to 30mm). This results in too much play on the threads for the nuts to fully lock as designed.

The picture below shows a M30 Hard-Lock male and female nut pair fitted to an adjustable stretcher bar. The nuts have been hand tightened but there is no visible gap between the nuts.

It is important that there is a gap of approximately 2mm present between the male and female nuts after they have been tightened by hand, before the installation torque value is applied. If the gap is not present, the lock nut may not provide its full intended locking effect.

1. Before tightening to the installation torque of 300 Nm, the interlocking cones of the male and female nuts are to be initially engaged to hand tightness -there shall be a visible gap (approximately 2mm) between the nuts. A 1.5mm gauge can be used to check the size of the gap.

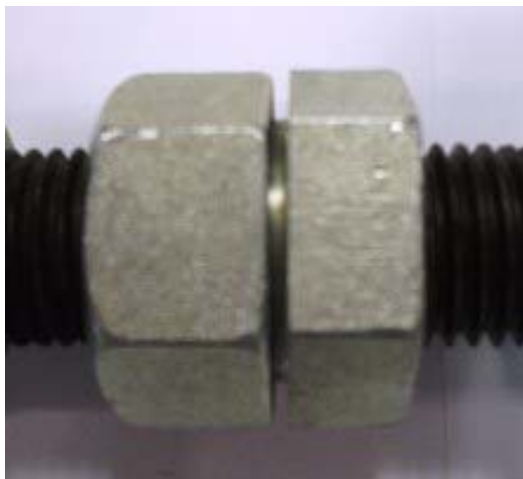
The picture below shows a suitable gap between the male and female nuts
