# **Environmental cleanliness in enclosed spaces – Guide to in situ high efficiency filter leak testing**

ICS 13.040.30

This Published Document is published by BSI and came into effect on 31 July 2007. It was prepared by Technical Committee LBI/30, *Cleanroom technology*. A list of organizations represented on this committee can be obtained on request to its secretary.

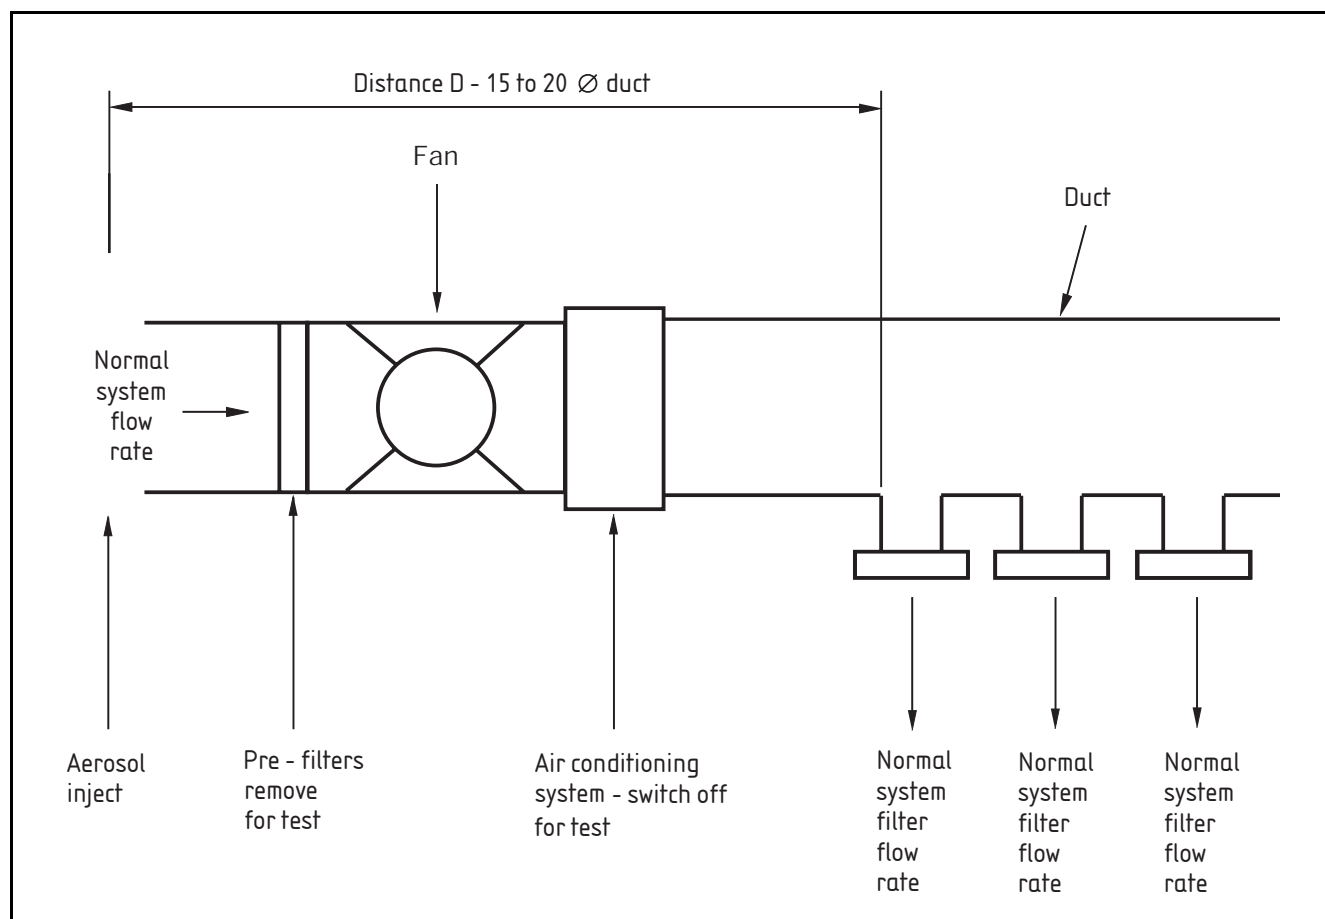
Figure 1 **Diagram of an aerosol challenge to multiple filters via an air handling unit**

To ensure good mixing it is essential that the aerosol is injected correctly. For ducted systems, aerosol injection ports will normally be required. When injecting into long ducted systems with distribution legs along the main duct (see Figure 1), good mixing will not occur unless the distance  $D$  is at least 15 duct diameters. However the correct use of distribution sparge pipes may allow injection as near as one metre from the filter face to achieve homogeneous distribution of the challenge aerosol.

The filter integrity test relies on a homogeneous distribution of aerosol test challenge upstream and across the whole filter face. Homogeneous distribution is defined as a variation in concentration of less than  $\pm 15\%$  in time about the average measured value. The upstream aerosol challenge should be measured as close as possible to the filter, and ideally not more than 50 mm from the upstream face.
