# Data Extraction Methods and their Effects on the Retention of Event Data Contained in the Electronic Control Modules of Detroit Diesel and Mercedes-Benz Engines

2011-01-0808

David Plant  
D P Plant & Associates

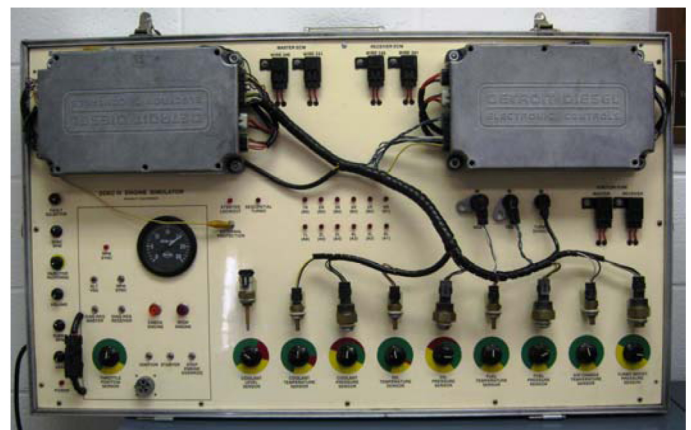
*Figure 1. DDEC-IV Engine Simulator*

Shown in [Figure 1](#) is the DDEC-IV Engine Simulator used for testing. With the engine simulator, the simulated ignition

key was switched on, and the dial for the simulated throttle turned to increase the engine speed and run the simulated engine. After operating the simulated engine for several minutes, active faults were created by simply turning the dials associated with the Coolant Level and Oil Pressure sensors. A PC was connected to the Diagnostic Connector, and the Snapshot mode of DDDL used for Event Markers to record both when the dials to the Coolant Level sensor and the Oil Pressure sensor were turned, and when the faults became active. The simulated ignition key switch was then turned off. These steps were repeated between the data extraction methods. The simulated ignition key switch was then turned on, and one of the three data extraction methods was applied to image the ECM. Again the order of the data extraction methods was a Diagnostic Connector image followed by the On-Truck image, followed by the Bench image. The data obtained from the three data extraction methods were compared to data extracted during the Baseline image, with differences between the extraction method and baseline extraction noted.
