# Analysis of the Effectiveness of Evaporator's Hydrophilic Coating of Cores Recovered from Humid and Arid Regions

Gursaran D. Mathur  
 CalsonicKansei North America Inc.

**CITATION:** Mathur, G., "Analysis of the Effectiveness of Evaporator's Hydrophilic Coating of Cores Recovered from Humid and Arid Regions," *SAE Int. J. Passeng. Cars - Mech. Syst.* 10(1):2017, doi:10.4271/2017-01-0122.

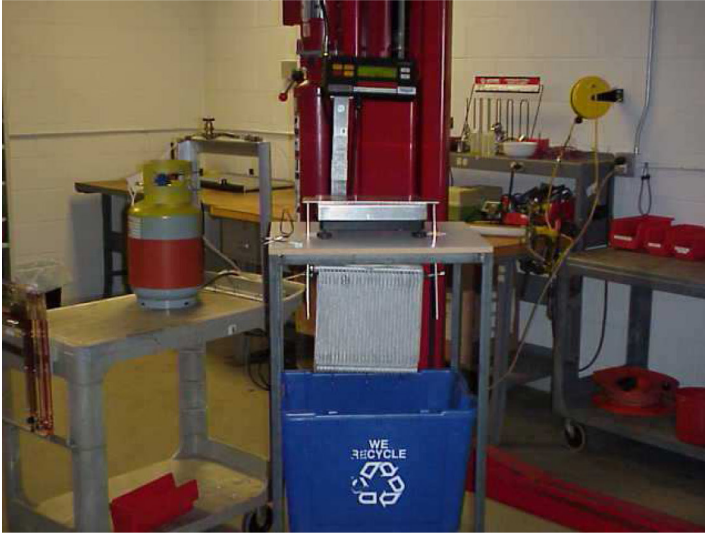
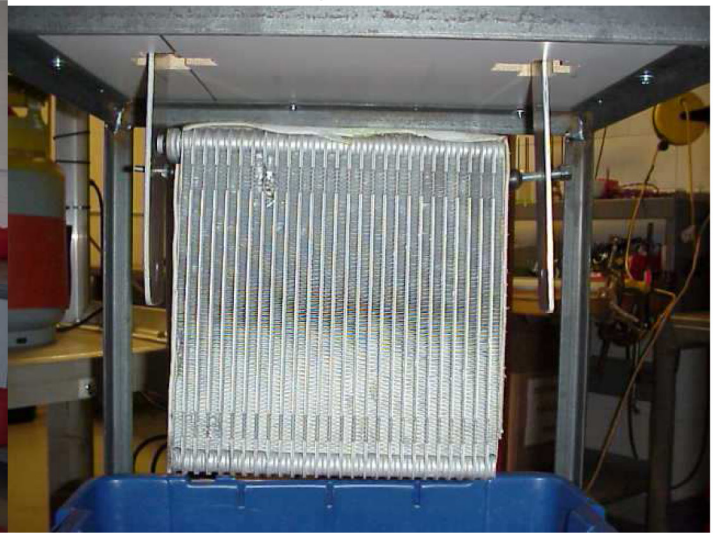
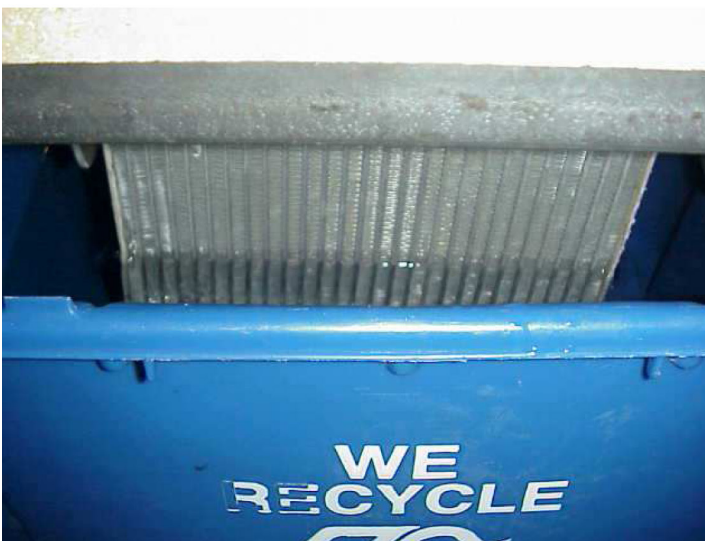
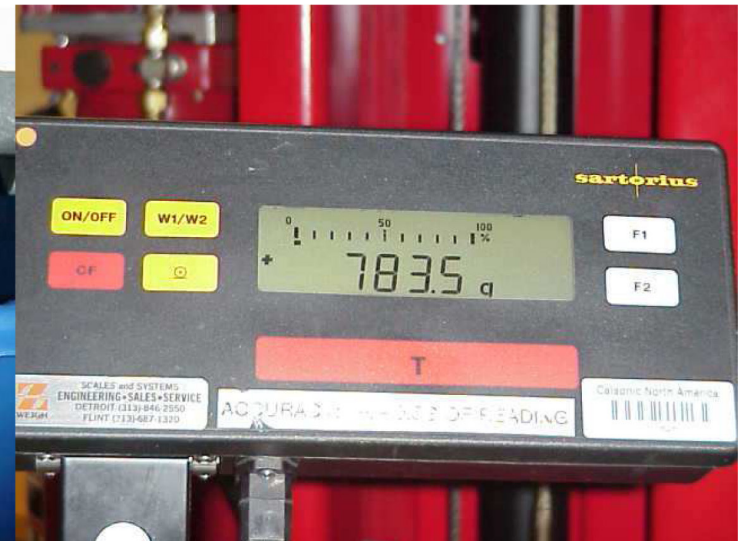
Figure 1. Schematic of the Water Retention Test (Mathur, 2016) – (a) Side View of the Set-up; (b) An Evaporator attached to the mechanism that measures weight; (c) Close-up of Water Level in Evaporator; (d) Scale on top of Table to Measure Weight

The test details are given in Figures 1 (a thru d) and 2 (a thru d). A container filled with water was used for this investigation. The container could be moved up and down to completely dunk the evaporator core in water. The water temperature was measured through a thermocouple. Ice was mixed with water to reduce average water temperature to investigate the influence of surface tension as a function of average water bath temperature. The evaporator core was tapped on the sides to remove trapped air bubbles from the cores. A weight scale with an accuracy of  $\pm 1$  gm was used for this investigation. A number of tests were repeated at water bath temperatures of 5, 10 and  $15^\circ\text{C}$ , respectively. The test repeatability was within  $\pm 10$  gm. The whole container was moved below the core to measure the water retention in cores. The following is the sequence of the test for a given average water temperature:

- Set water bath temperature (say  $5^\circ\text{C}$ )
- Move lift in upwards vertical direction until the evaporator is covered with water within the water bath.
- Tap the evaporator to remove trapped air bubbles
- Now slowly move the lift vertically downwards – this will lower the water bath. Bring the water bath below the bottom of the evaporator core.
- At this time, water from the evaporator core will start to drain due to gravity. After a certain time, water draining will stop.
- Record the weight of the evaporator core plus water. Subtracting evaporator core weight from this number will result in the water contained within the evaporator core.
